Repair Procedure

RP-11062-015

| Subject: | IMPORTANT: TRW Mode Change and Hyundai/Kia | | |

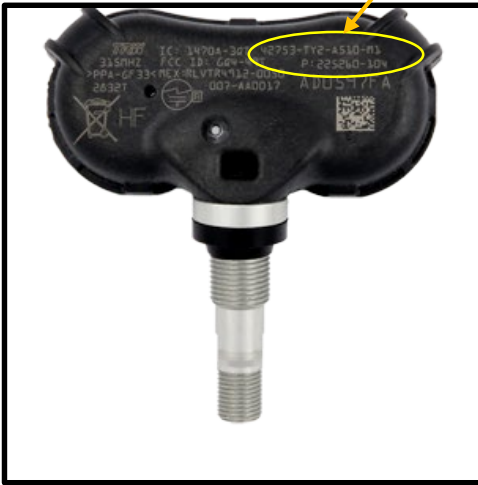
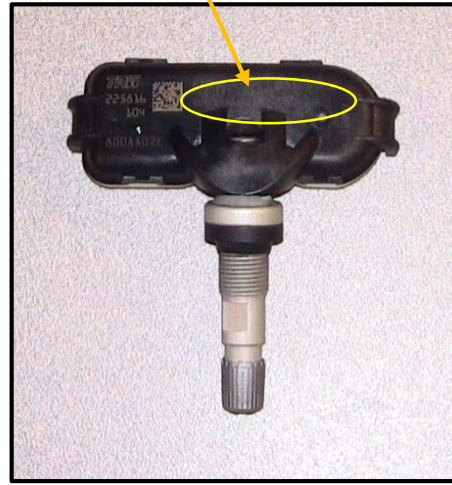
Sensors Affected:

NOTE: When these sensors are triggered with old software, the mode is unnecessarily changed, causing a communication problem with the car. All other processes behave normally [triggering and relearn communications]. The mode change however causes the sensor to NOT communicate with the car. Currently the sensors CANNOT BE CHANGED BACK. Once the mode is changed, the sensors are not usable for any application.

Locate Part Number here

UPDATE YOUR TOOL TO R53.2 BEFORE REPAIRING HYUNDAI or KIA Vehicles!
